**Newport Banning Ranch LLC**

**PHASE I  
ENVIRONMENTAL SITE  
ASSESSMENT UPDATE  
NEWPORT BANNING RANCH  
ORANGE COUNTY, CALIFORNIA**

16 April 2008

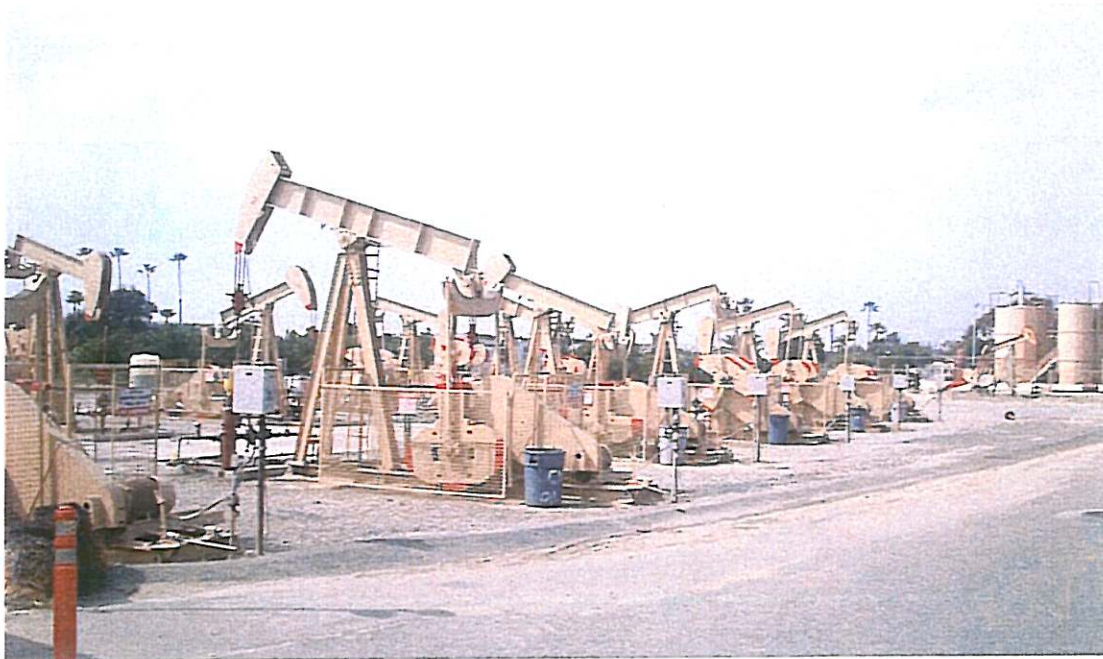
Photo No. 1      Photographer: Ryan Wohlstrom      Date: 12 March 2008  
Description: City of Newport Beach Oil Wells and Tank Farm Near PCH Entrance, Looking Northwest.  
Project: Newport Banning Ranch, Orange County, California

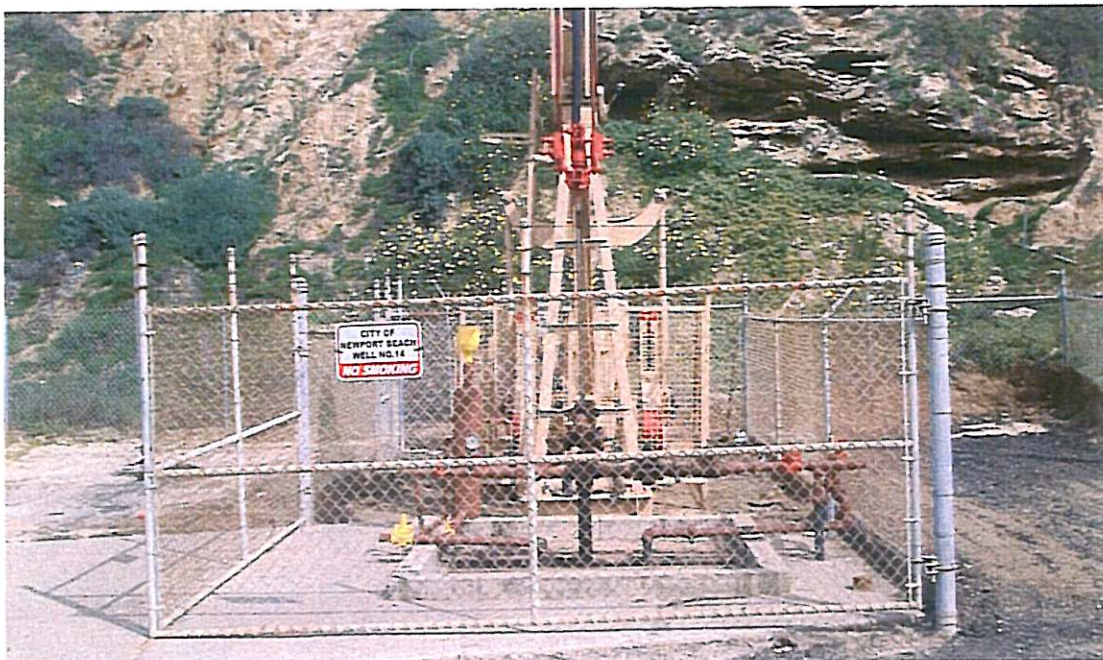
Photo No. 2      Photographer: Ryan Wohlstrom      Date: 12 March 2008  
Description: City of Newport Beach Active Oil Well Near PCH Entrance, Looking East.  
Project: Newport Banning Ranch, Orange County, California

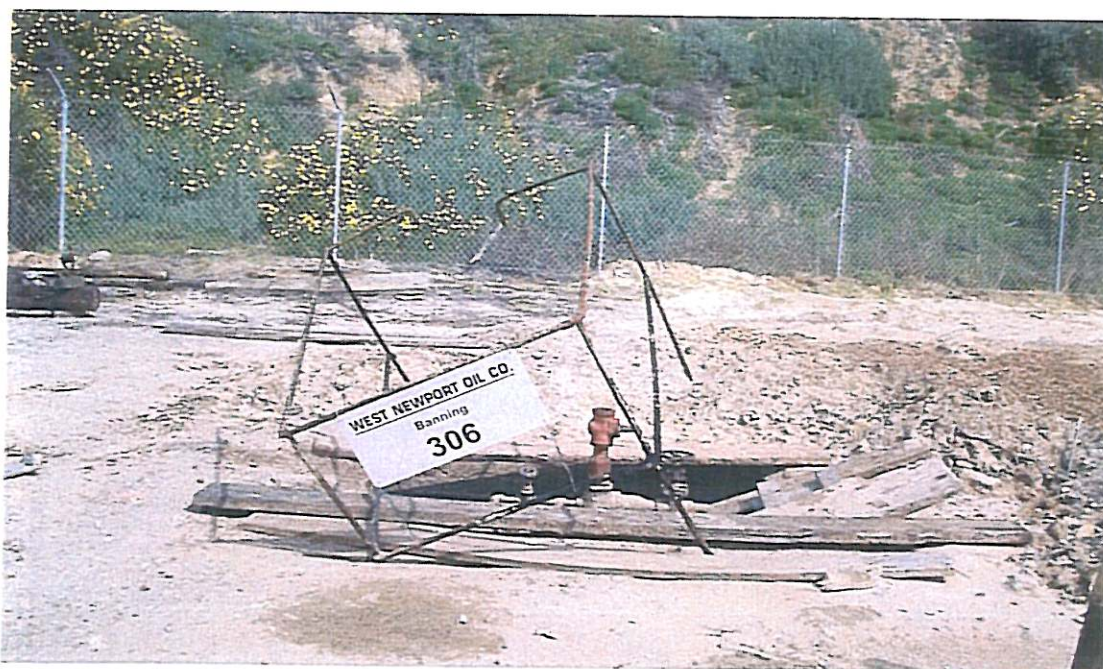
Photo No. 3      Photographer: Ryan Wohlstrom      Date: 12 March 2008  
Description: West Newport Oil Company Abandoned Well, Looking East.  
Project: Newport Banning Ranch, Orange County, California

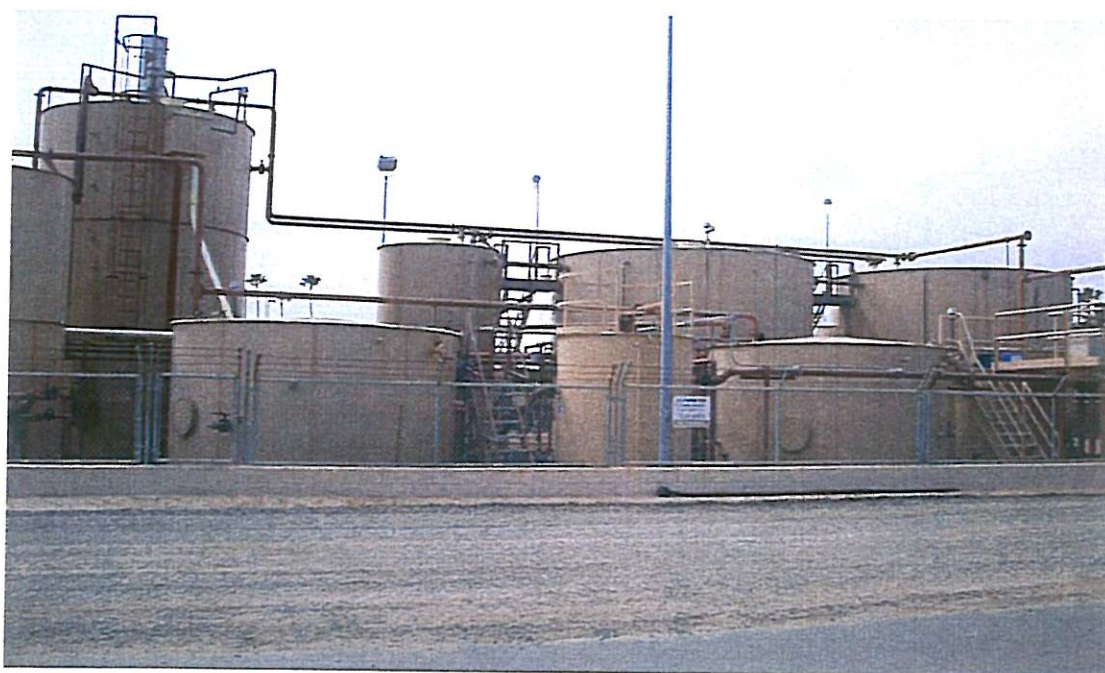
Photo No. 4      Photographer: Ryan Wohlstrom      Date: 12 March 2008  
Description: City of Newport Beach Tank Farm, Looking West.  
Project: Newport Banning Ranch, Orange County, California

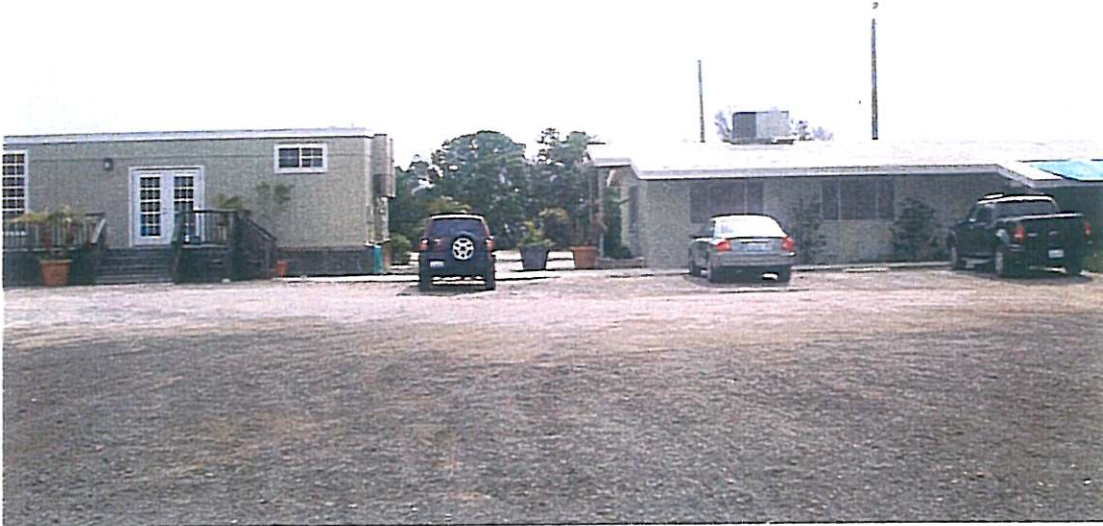
Photo No. 5      Photographer: Ryan Wohlstrom      Date: 12 March 2008  
Description: Main Office & Proposed Area for Future Visitor-Serving Commercial Site, Looking South.  
Project: Newport Banning Ranch, Orange County, California

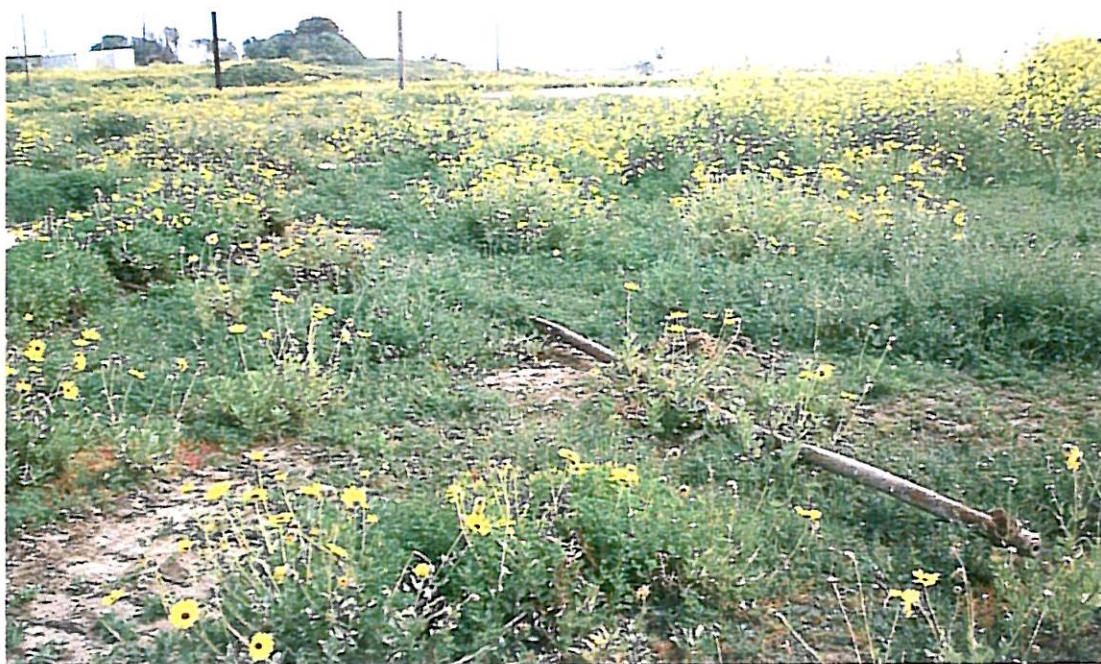
Photo No. 10      Photographer: Ryan Wohlstrom  
Description: Abandoned Oil Pipeline (Observed Throughout Property), Looking Southwest.  
Project: Newport Banning Ranch, Orange County, California

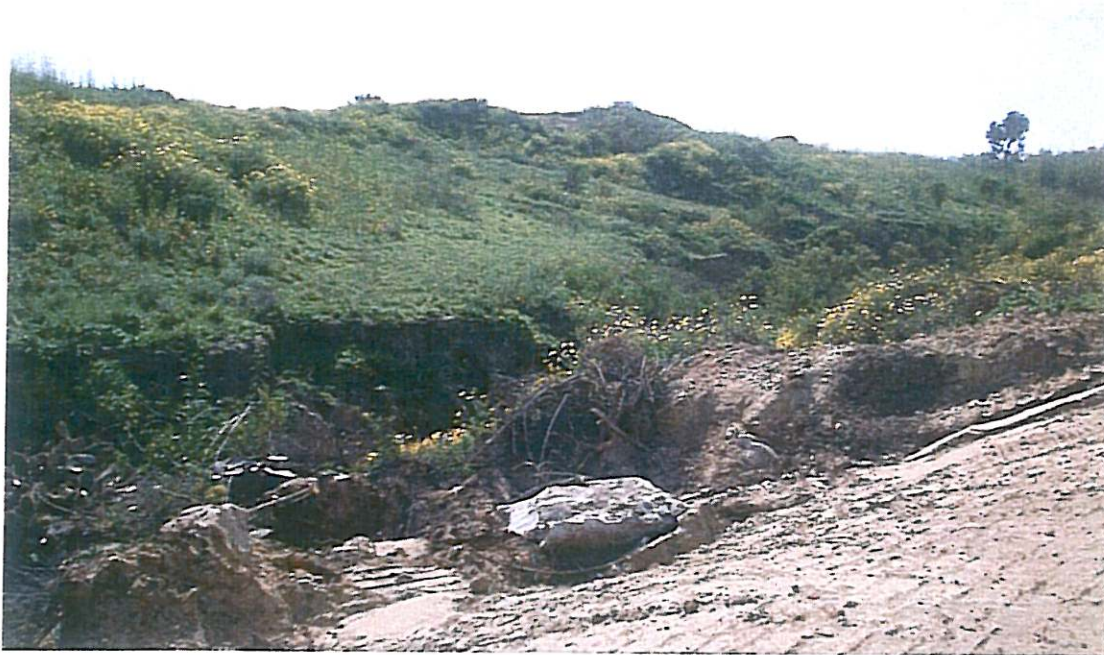
Photo No. 11      Photographer: Ryan Wohlstrom      Date: 12 March 2008  
Description: Miscellaneous Debris Observed In Trench, Looking Southwest.  
Project: Newport Banning Ranch, Orange County, California

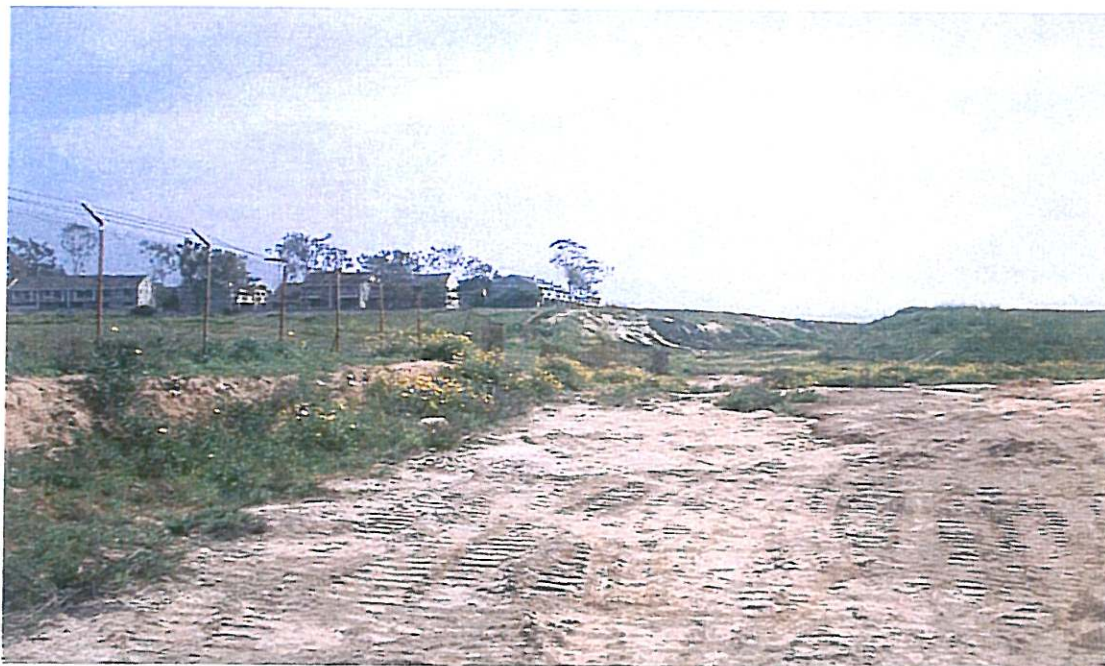
Photo No. 12      Photographer: Ryan Wohlstrom      Date: 12 March 2008  
Description: Proposed Area For Future Residential Land Use, Looking South.  
Project: Newport Banning Ranch, Orange County, California

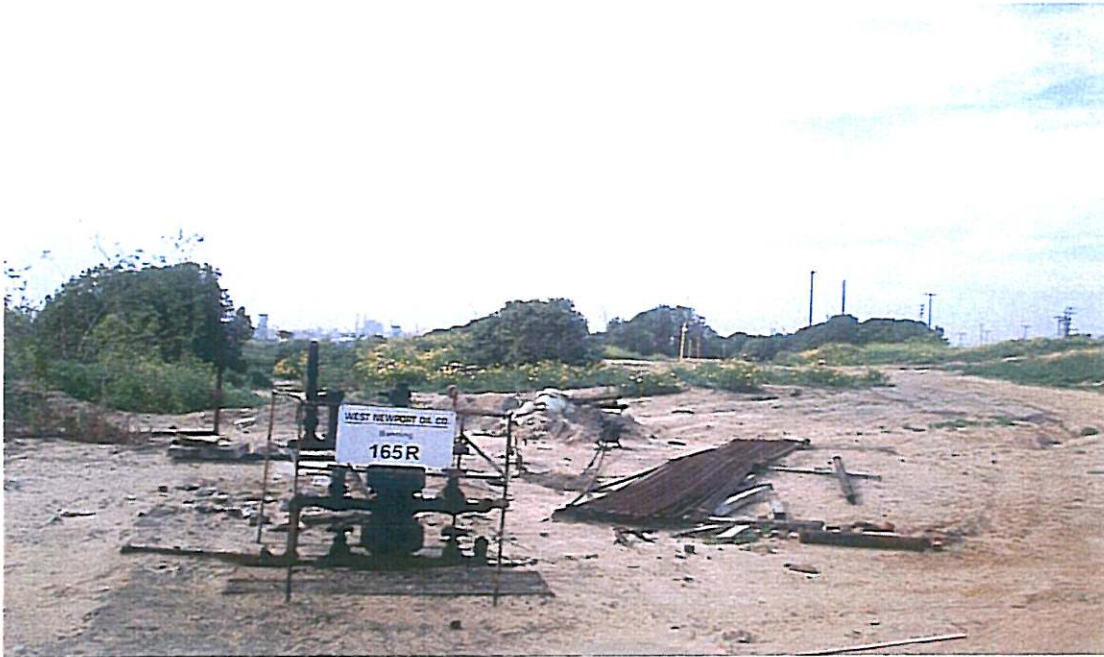
Photo No. 21      Photographer: Ryan Wohlstrom      Date: 12 March 2008  
Description: Abandoned Oil Well and Miscellaneous Oil Equipment, Looking West.  
Project: Newport Banning Ranch, Orange County, California

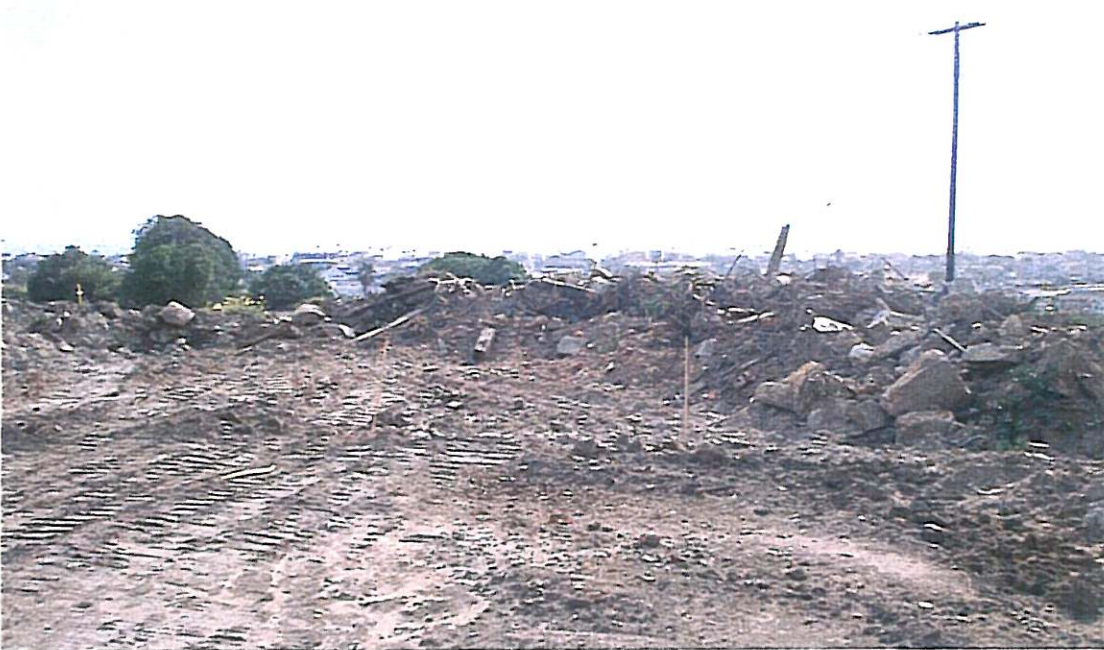
Photo No. 22      Photographer: Ryan Wohlstrom      Date: 12 March 2008  
Description: Concrete Storage and Miscellaneous Debris Stockpiles, Looking South.  
Project: Newport Banning Ranch, Orange County, California

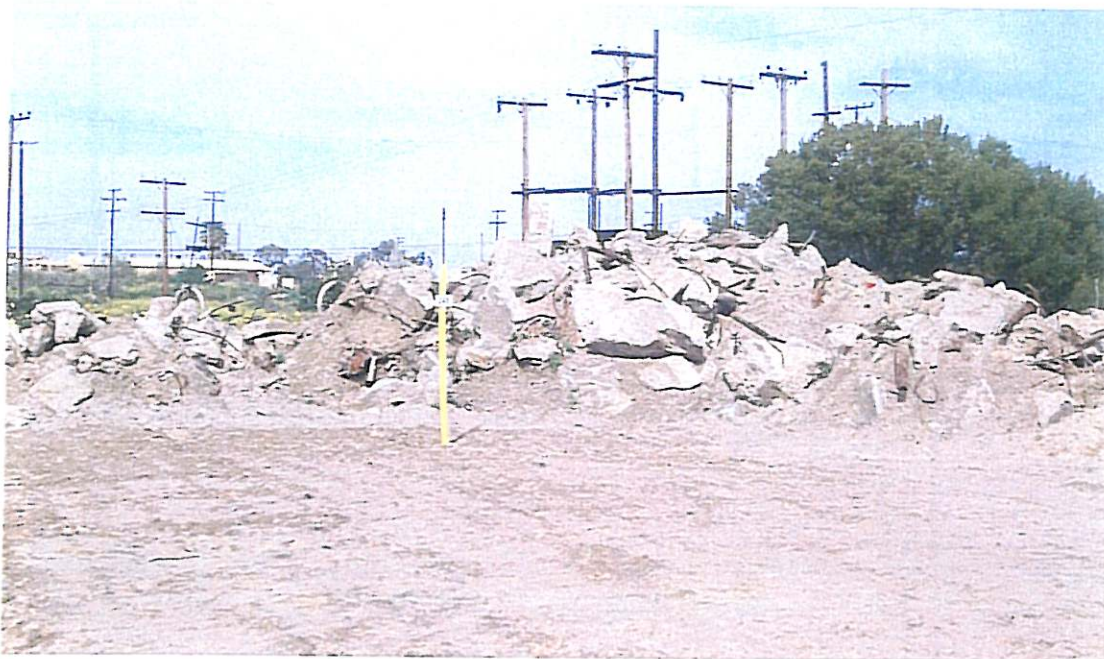
Photo No. 23      Photographer: Ryan Wohlstrom      Date: 12 March 2008  
Description: Concrete Storage and Miscellaneous Debris Stockpiles, Looking Southeast.  
Project: Newport Banning Ranch, Orange County, California

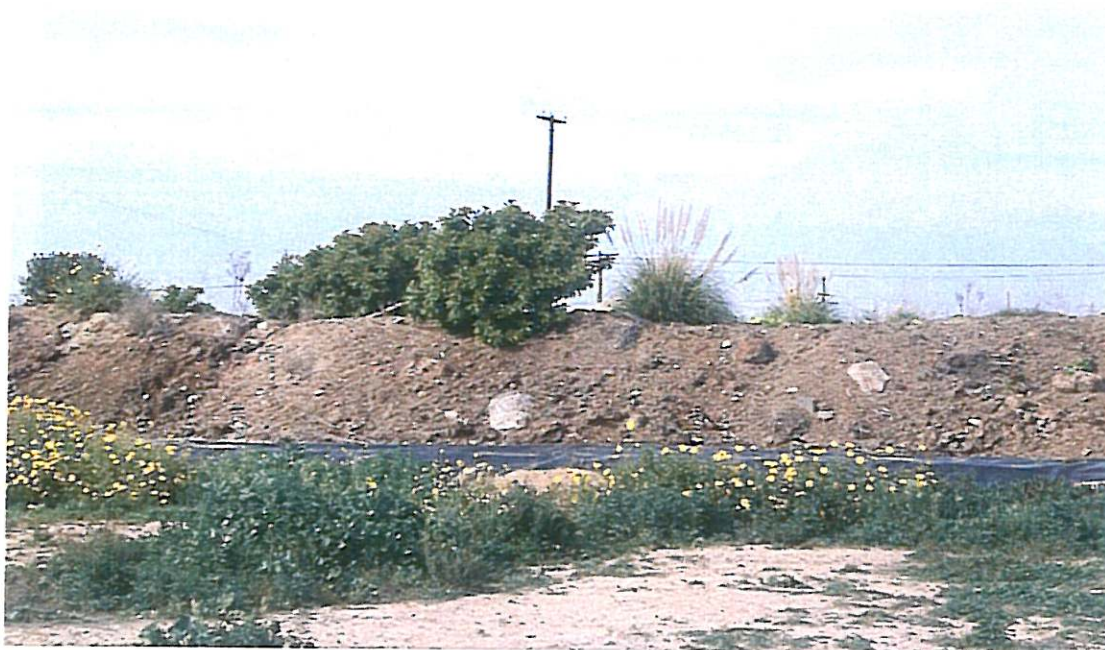
Photo No. 24      Photographer: Ryan Wohlstrom      Date: 12 March 2008  
Description: Impacted Soil Storage Area, Looking North.  
Project: Newport Banning Ranch, Orange County, California

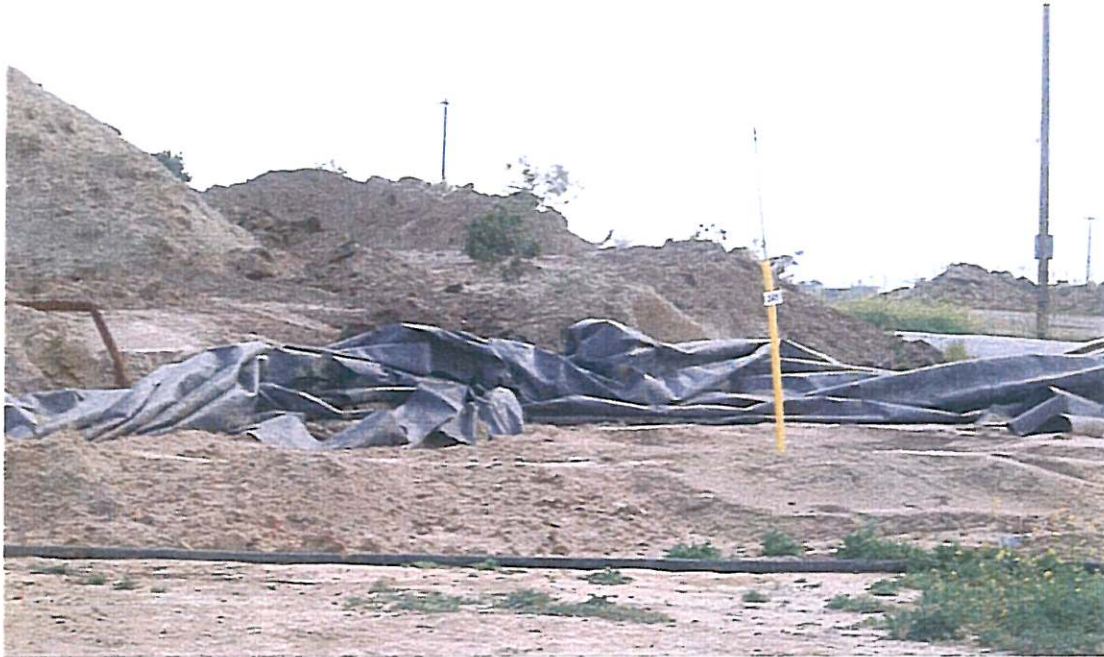
Photo No. 25      Photographer: Ryan Wohlstrom  
Description: Impacted Soil Storage Area, Looking South.  
Project: Newport Banning Ranch, Orange County, California

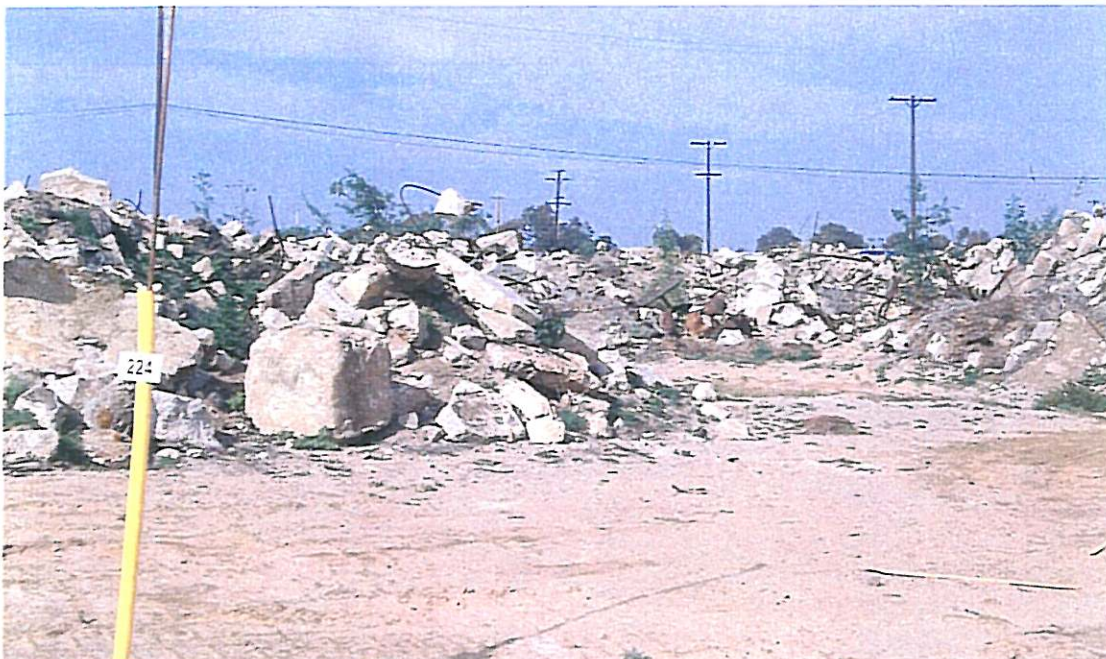
Photo No. 26      Photographer: Ryan Wohlstrom  
Description: Concrete Storage and Miscellaneous Debris Stockpiles, Looking East.  
Project: Newport Banning Ranch, Orange County, California

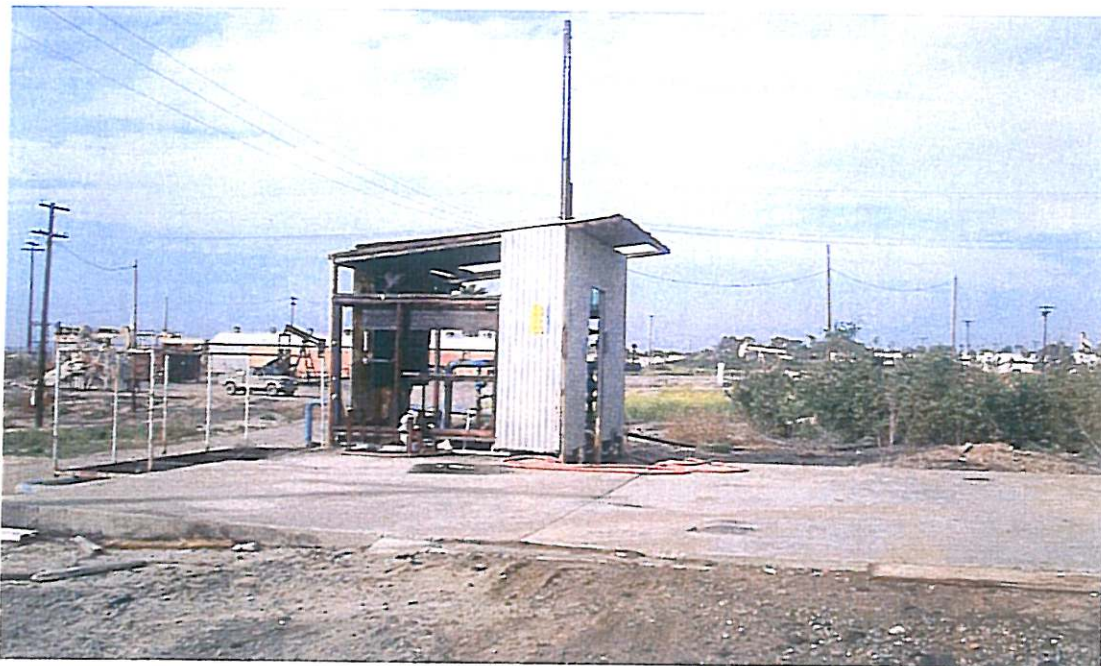
Photo No. 27      Photographer: Ryan Wohlstrom      Date: 12 March 2008  
Description: Element Of Inactive Water Softening Plant, Looking Northwest.  
Project: Newport Banning Ranch, Orange County, California

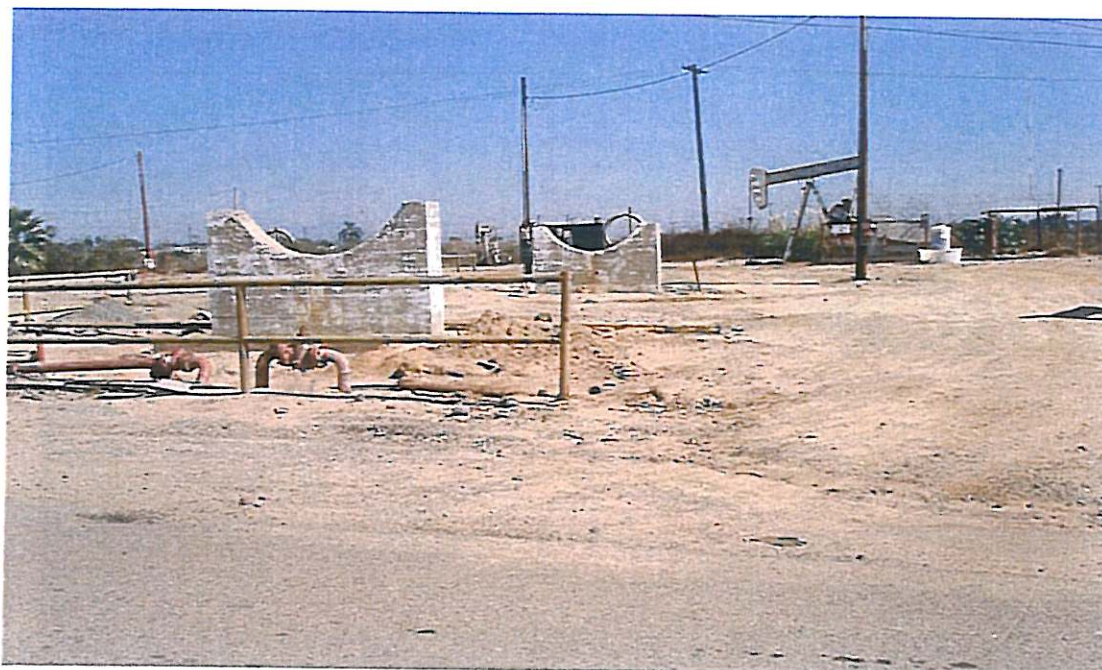
Photo No. 28      Photographer: Ryan Wohlstrom      Date: 12 March 2008  
Description: Former AST Mounting Brackets Near Former Gasoline Fill Area, Looking East.  
Project: Newport Banning Ranch, Orange County, California

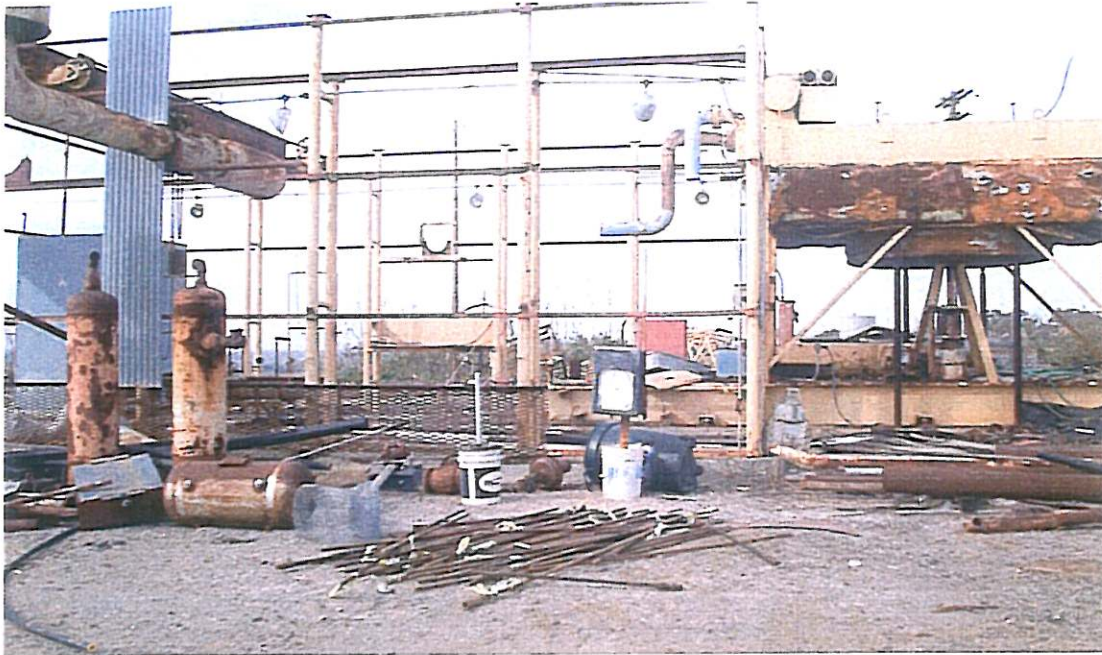
Photo No. 29      Photographer: Ryan Wohlstrom  
Description: Inactive Air Compressor Plant, Looking North.  
Project: Newport Banning Ranch, Orange County, California

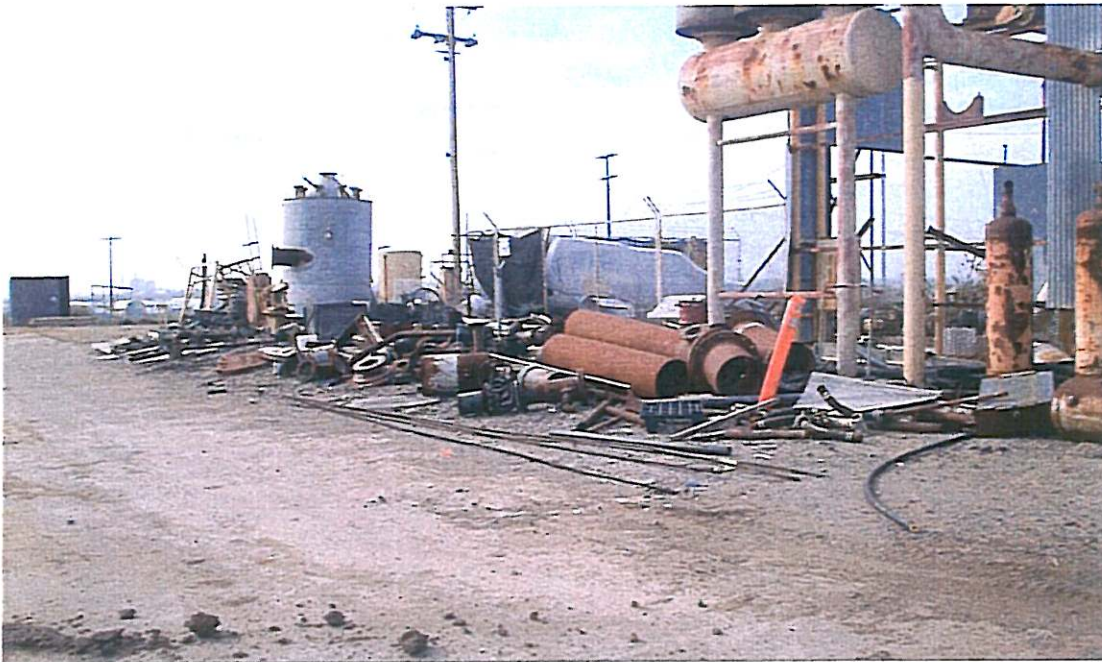
Photo No. 30      Photographer: Ryan Wohlstrom  
Description: Inactive Air Compressor Plant With Miscellaneous Equipment, Looking Northwest.  
Project: Newport Banning Ranch, Orange County, California

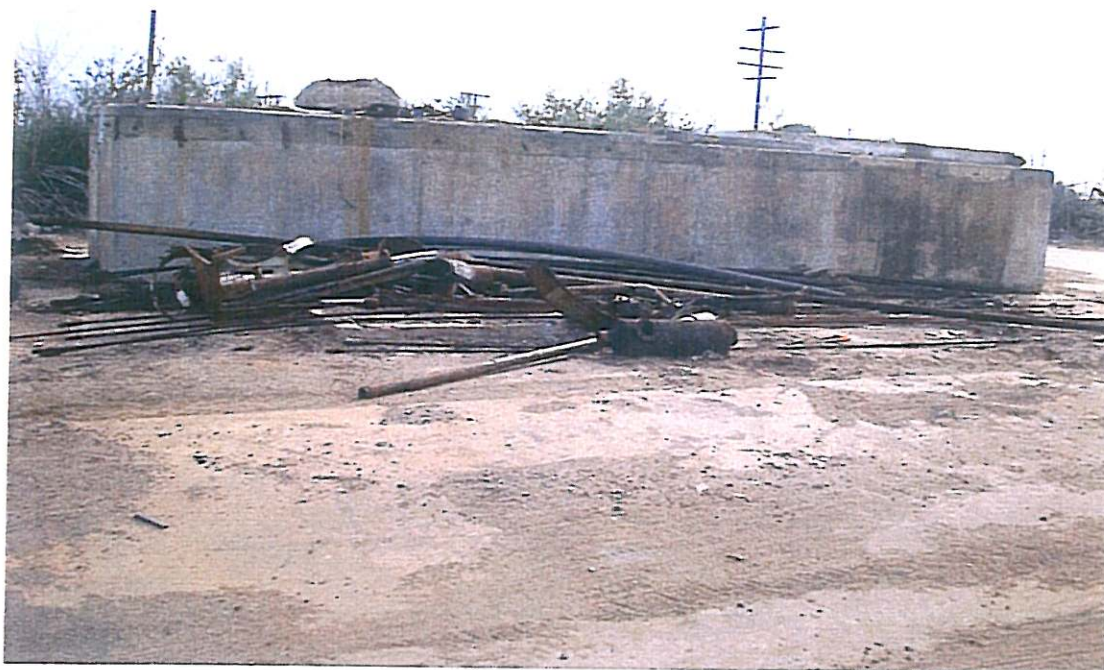
Photo No. 31      Photographer: Ryan Wohlstrom      Date: 12 March 2008  
Description: Concrete Storage and Miscellaneous Debris, Looking West.  
Project: Newport Banning Ranch, Orange County, California

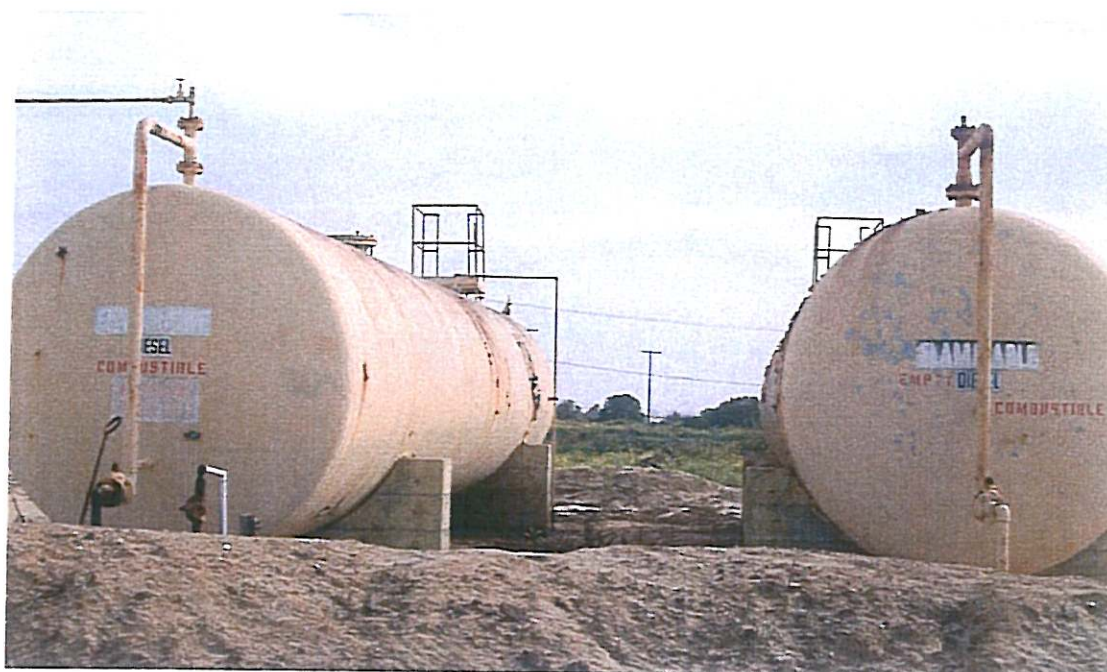
Photo No. 32      Photographer: Ryan Wohlstrom      Date: 12 March 2008  
Description: Above Ground Storage Tanks, Looking South.  
Project: Newport Banning Ranch, Orange County, California

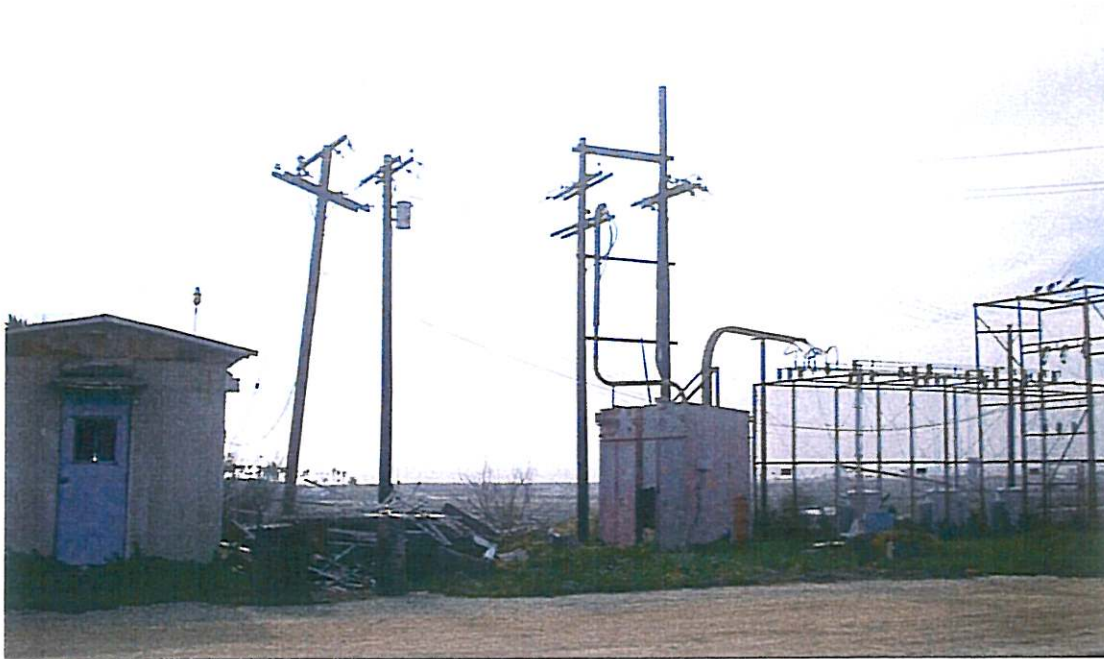
Photo No. 33      Photographer: Ryan Wohlstrom      Date: 12 March 2008  
Description: Small Shed Near Area Of Transformer Mounts, Looking South.  
Project: Newport Banning Ranch, Orange County, California

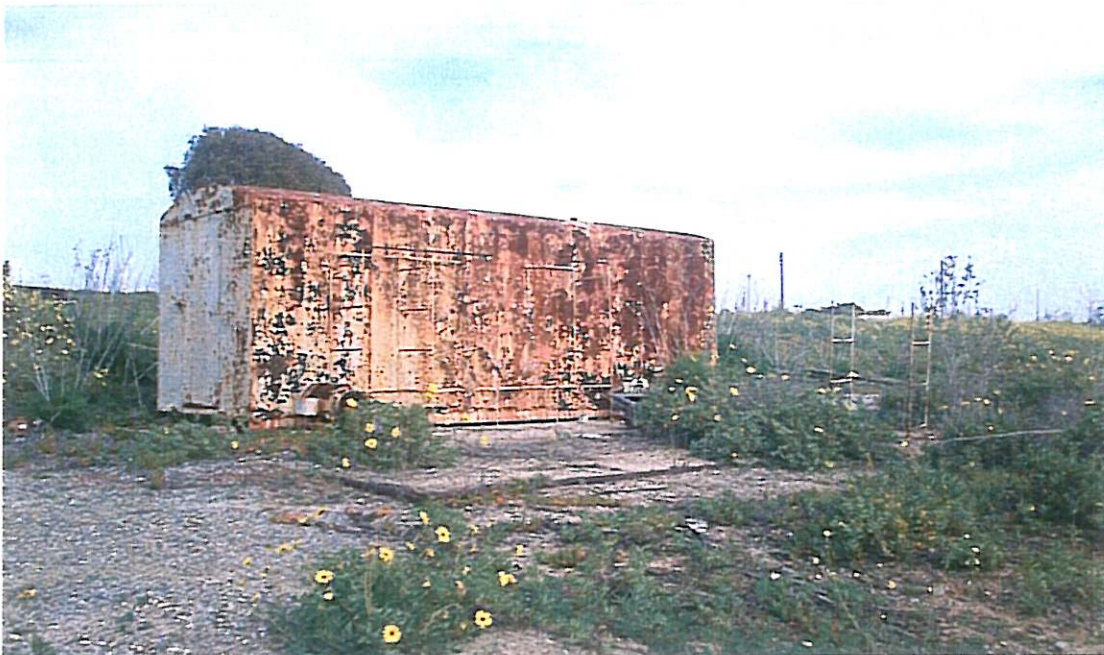
Photo No. 34      Photographer: Ryan Wohlstrom      Date: 12 March 2008  
Description: Old Storage Shed, Looking Northeast.  
Project: Newport Banning Ranch, Orange County, California

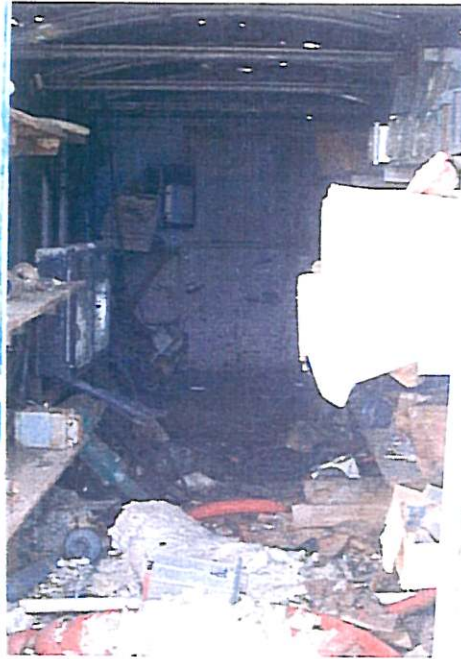
Photo No. 35      Photographer: Ryan Wohlstrom  
Description: Contents of Old Storage Shed, Looking North.  
Project: Newport Banning Ranch, Orange County, California

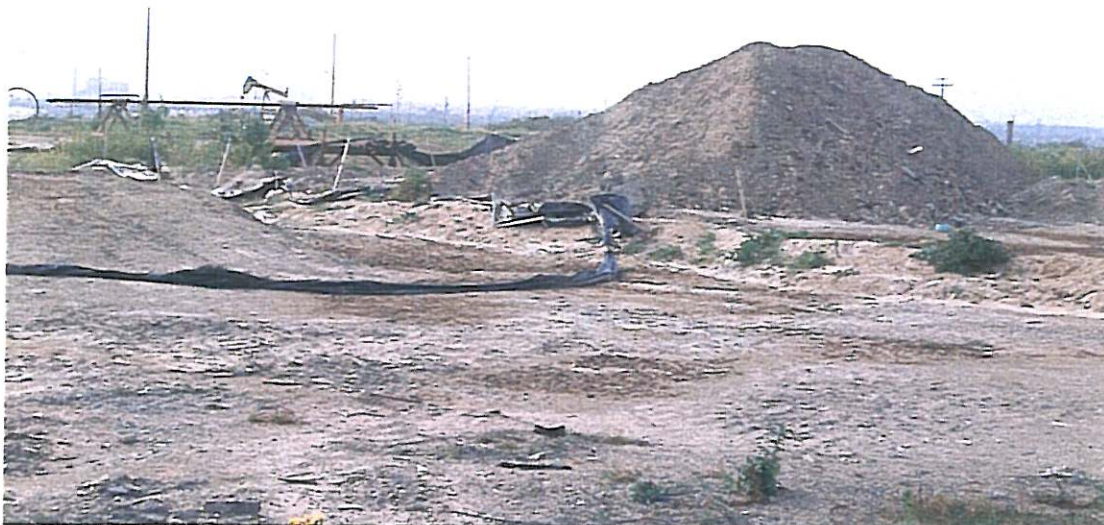
Photo No. 36      Photographer: Ryan Wohlstrom  
Description: Soil Stockpile Near Equipment Storage Area, Looking West.  
Project: Newport Banning Ranch, Orange County, California

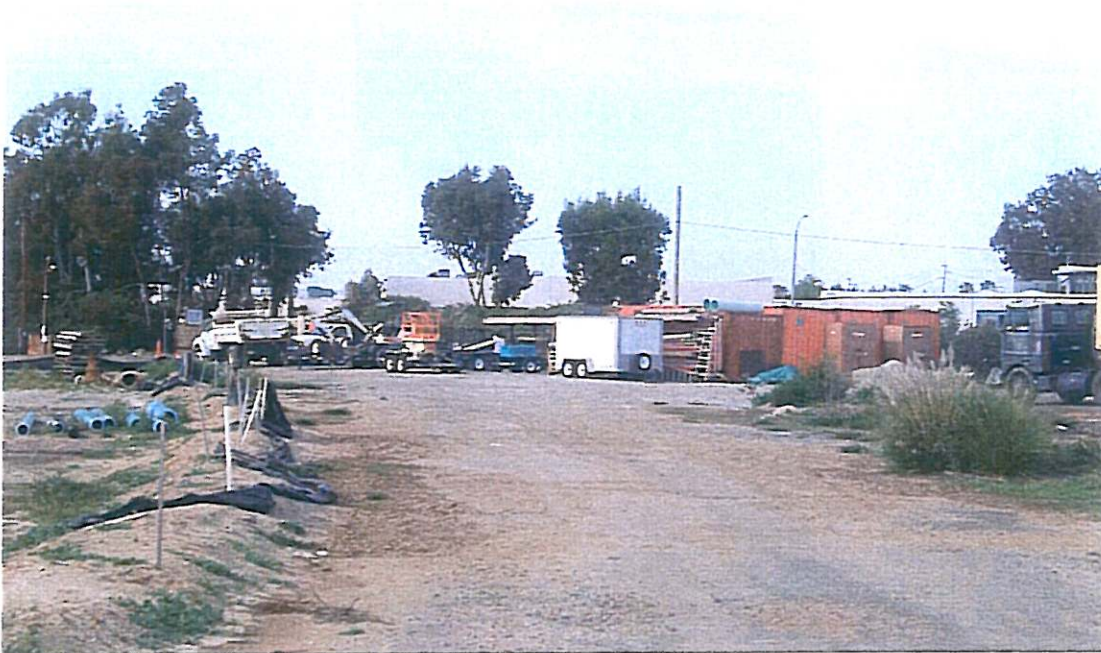
Photo No. 37      Photographer: Ryan Wohlstrom      Date: 12 March 2008  
Description: Equipment Storage Area Near 17<sup>th</sup> Street Entrance, Looking Northeast.  
Project: Newport Banning Ranch, Orange County, California

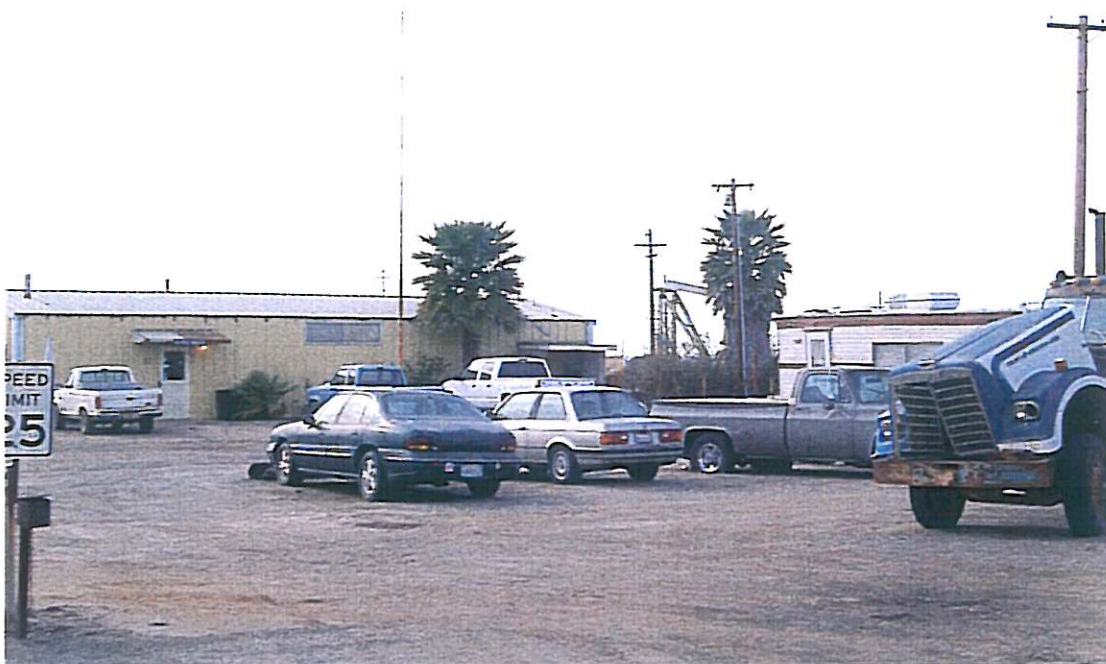
Photo No. 38      Photographer: Ryan Wohlstrom      Date: 12 March 2008  
Description: Equipment Storage Area and Offices Near 17<sup>th</sup> Street Entrance, Looking West.  
Project: Newport Banning Ranch, Orange County, California

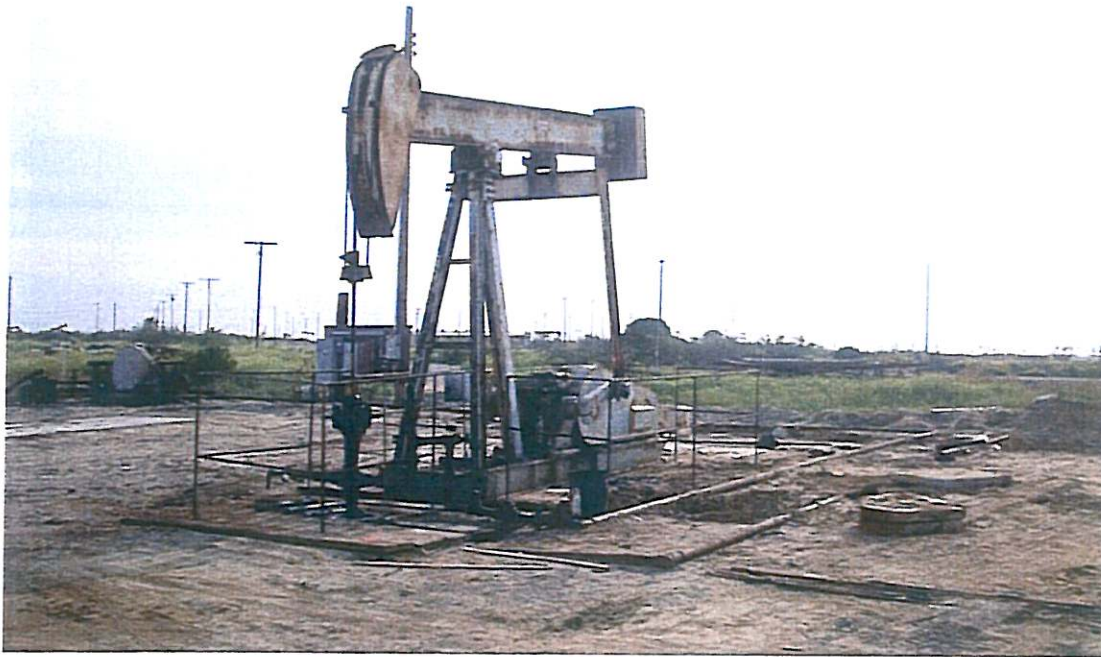
Photo No. 39      Photographer: Ryan Wohlstrom      Date: 12 March 2008  
Description: Active Oil Well Near Area Of Office and Changing Rooms, Looking Southwest.  
Project: Newport Banning Ranch, Orange County, California

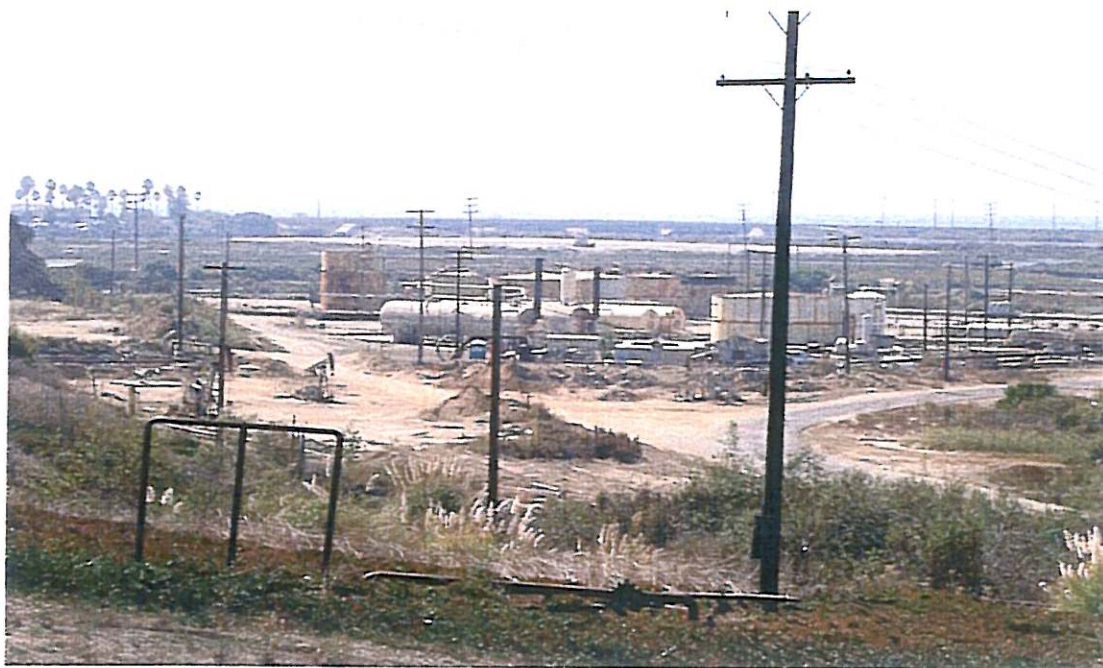
Photo No. 40      Photographer: Ryan Wohlstrom      Date: 12 March 2008  
Description: Overview of Main Site Tank Farm, Looking West.  
Project: Newport Banning Ranch, Orange County, California

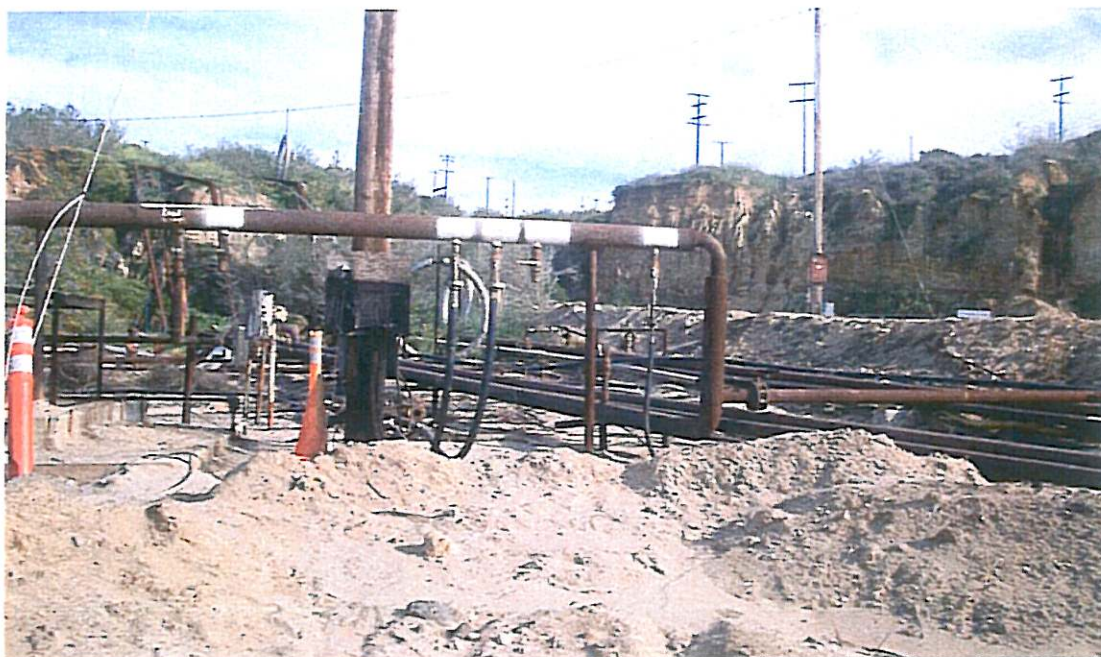
Photo No. 41      Photographer: Ryan Wohlstrom      Date: 12 March 2008  
Description: Oil Pipeline Near Main Site Tank Farm, Looking Southeast.  
Project: Newport Banning Ranch, Orange County, California

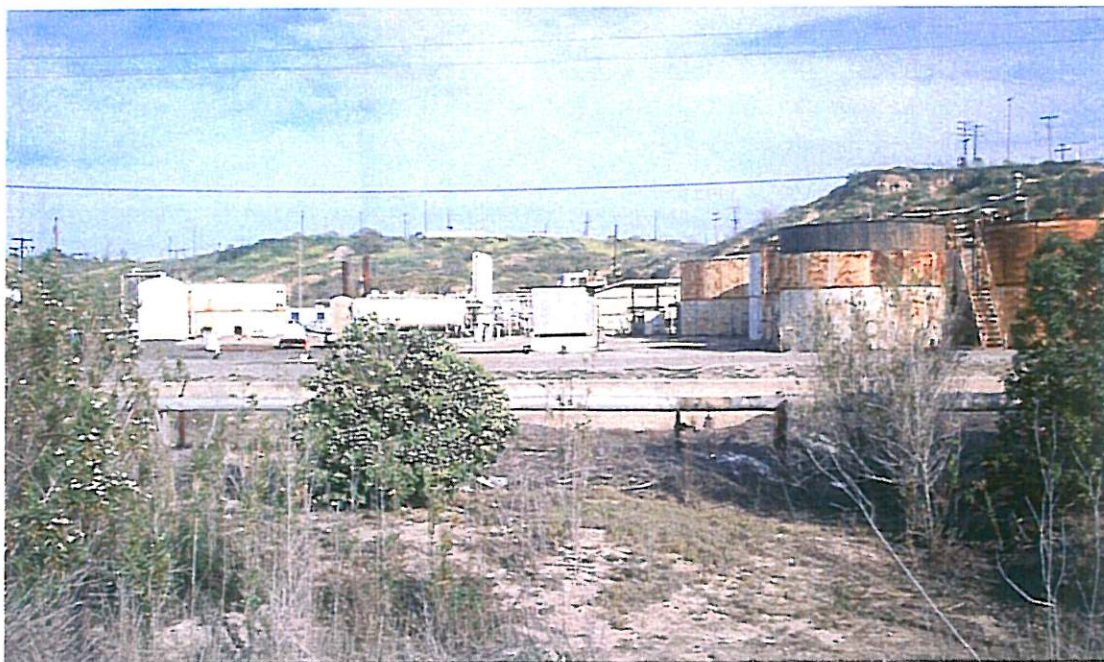
Photo No. 42      Photographer: Ryan Wohlstrom      Date: 12 March 2008  
Description: Main Site Tank Farm, Looking East.  
Project: Newport Banning Ranch, Orange County, California
